Vol. 40 No. 1 June 2023

Forensic Examination of Post-Fire Damaged Electrical Conductors by Using X-Ray Radiographs

By Mark J. Svare, PhD, PE, DFE (NAFE 851M) and Niamh Nic Daeid, PhD

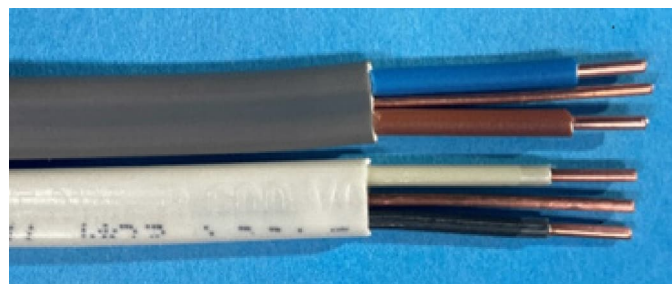
Figure 3

Non-metallic electrical cabling (UK and North America).

Examples of electrical equipment examined during an electrical survey and arcing fault evaluation may include (in part): electrical service equipment, electrical distribution panels (**Figure 2**), overcurrent protective devices, electrical feeders, branch circuits, appliances, luminaires, wiring, cables (**Figure 3**), and cords.

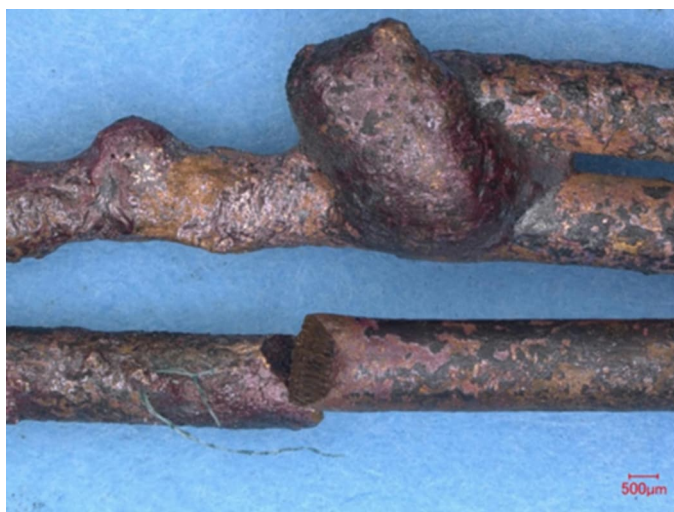
Figure 5
Example of electrical conductor fire melting damage²⁶.

Fire melt site features will generally form during fire and heat attack that exceeds the melting temperature of electrically conductive materials, such as aluminum, zinc, copper, or steel. Conductor melt sites (recognized as fire-melting damage) are generally identified in the form of gross melting and/or globule features (**Figure 5**). They may exhibit, in part, a non-uniform surface and shape, no clear lines of demarcation at the damage site, irregular melting features in and around the damage site, manufactured tool markings melted away from the damage site, and non-uniform porosity within the damage site.

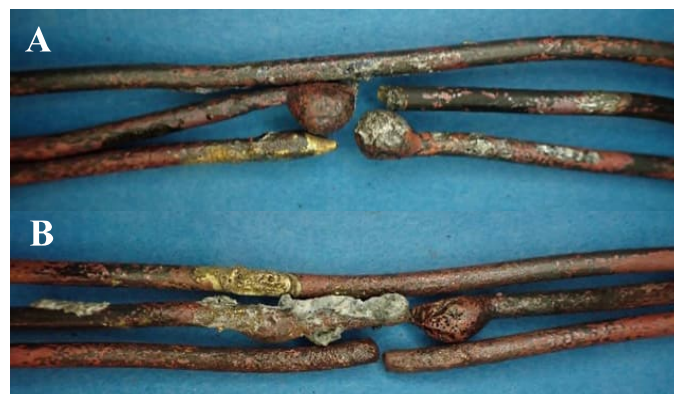
Figure 6
Examples of electrical conductor fire melting damage (alloying). Fire melting copper and aluminum (A) and fire melting copper and zinc fire (B)²⁶.

Alloying sites (mixed metal) are generally recognized as a fire-melting feature that occurs by the mixing or alloying of dissimilar materials at elevated temperatures, causing melting at the damage site. The effect may occur due to electrical equipment, components, and wiring of different materials (such as copper, aluminum, lead, tin, and zinc) coming in contact during the course of a fire. Alloying sites may exhibit features similar in appearance to fire melt sites. The alloying site may have a brass and/or silver color appearance (**Figure 6**). Alloying sites are commonly mischaracterized as eutectic melting.

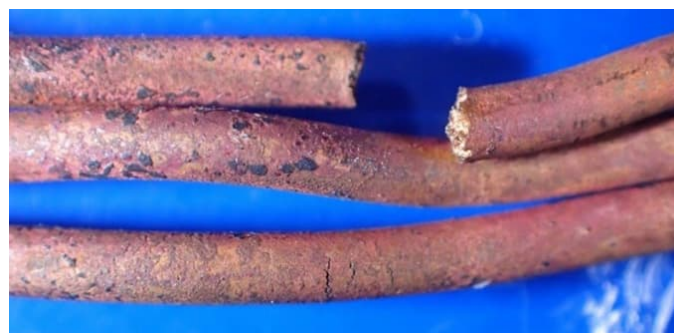
Figure 7
Example of electrical conductor mechanical damage²⁶.

Mechanical damage sites are generally recognized by fractured, impact, cracked, cut, sheared, stretched, or other damage from a mechanical action at the damage site (**Figure 7**). Mechanical damage can occur prior to the incident event or due to the excavation process involved in a scene investigation. Examples of this type of damage include: gouging/scraping of wires during installation or subsequent construction tasks; structural collapse causing conductors to stretch or break; or cutting by a tool.

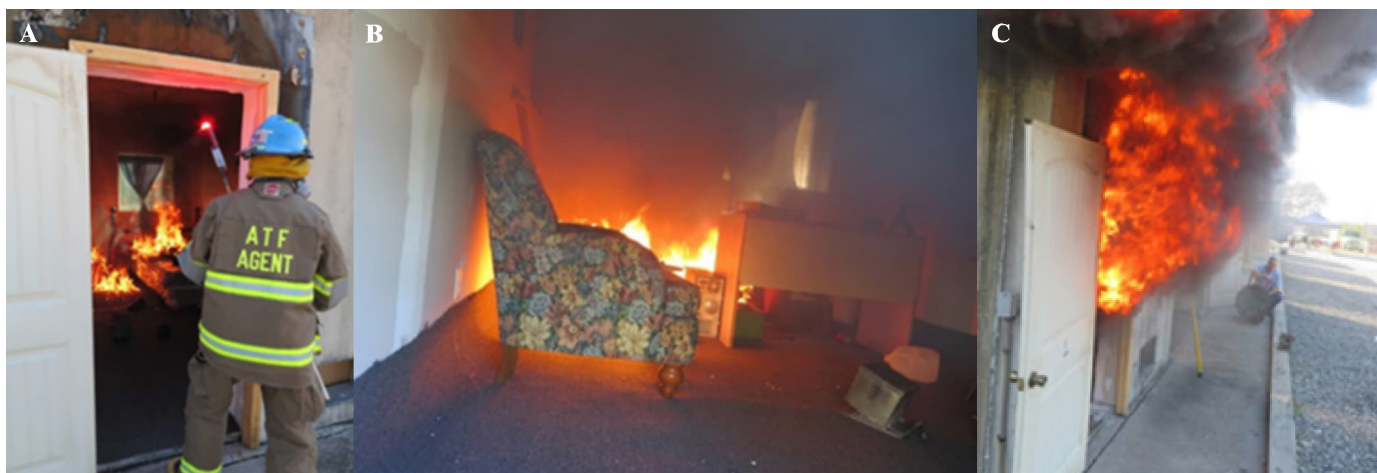
Figure 13

(A) Full-scale compartment fire testing at FLETC, (B) interior view of fire, and (C) post-flashover fire extending outside of compartment²⁶.

A total of 63 full-scale compartment fires were conducted at the United States’ Federal Law Enforcement, ATF fire training center (FLETC) located in Brunswick,

Georgia (**Figure 13**). The electrical distribution system under these tests was a 120/240VAC, single-phase, 15A electrical circuit. The available fault current at the point of fire impingement was calculated to be 210.9A.
